EXHIBIT F

Marcellin Fire Investigation

1.0 Introduction

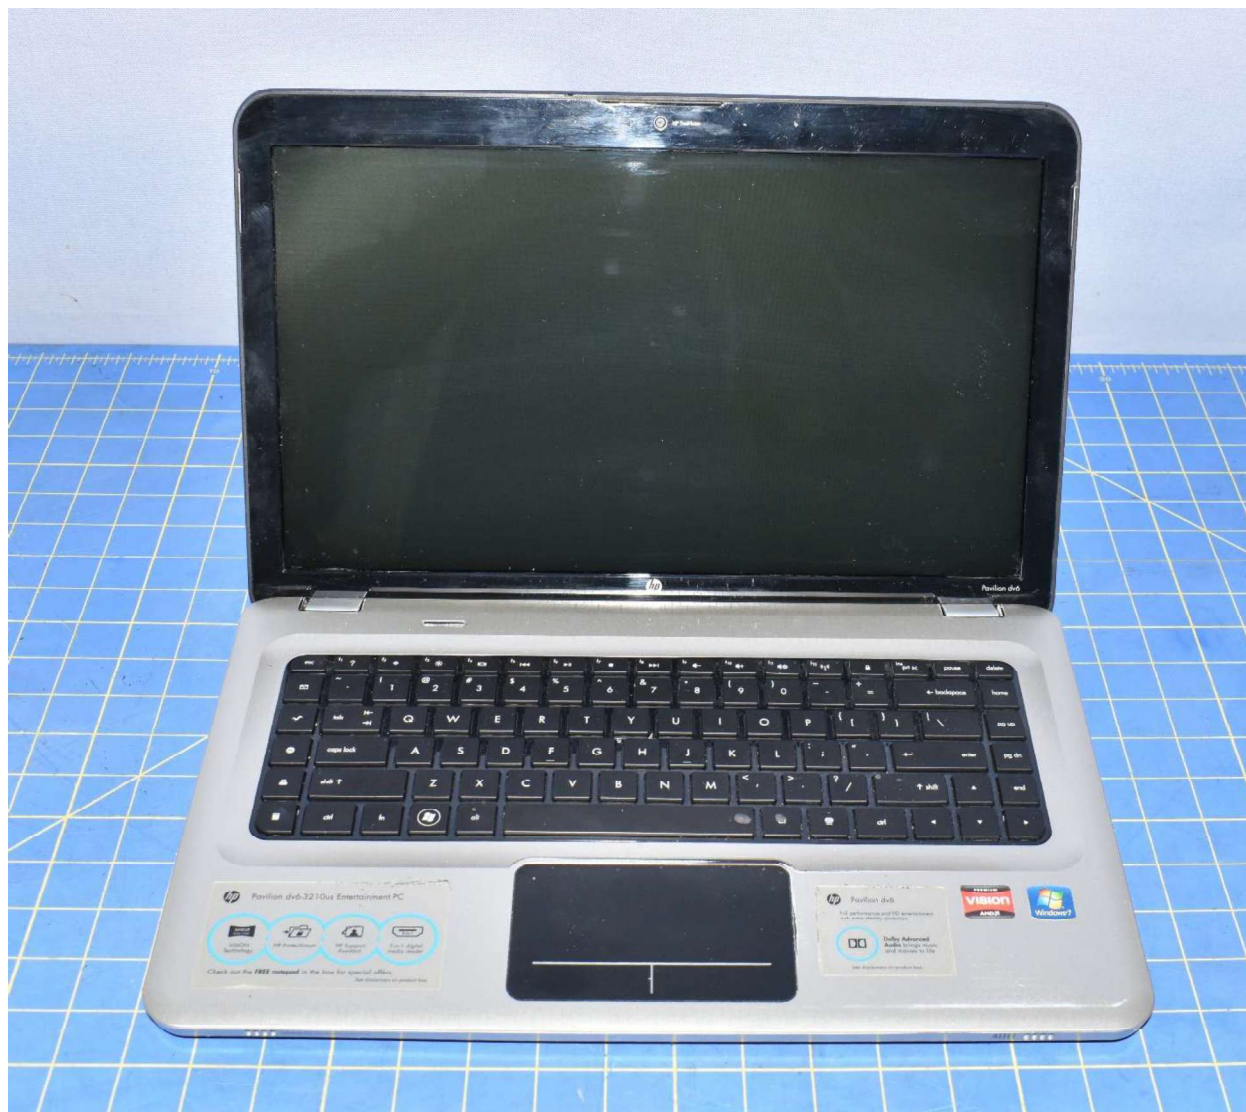
The computer is a model DV6-3210US. A photo of the general appearance of the top view of a sample of this computer is shown in Figure 2. The bottom of the computer is shown in Figure 3 in which the location of the battery pack is indicated by the dotted red line.

Figure 2. Photo of DV6 Computer Front View

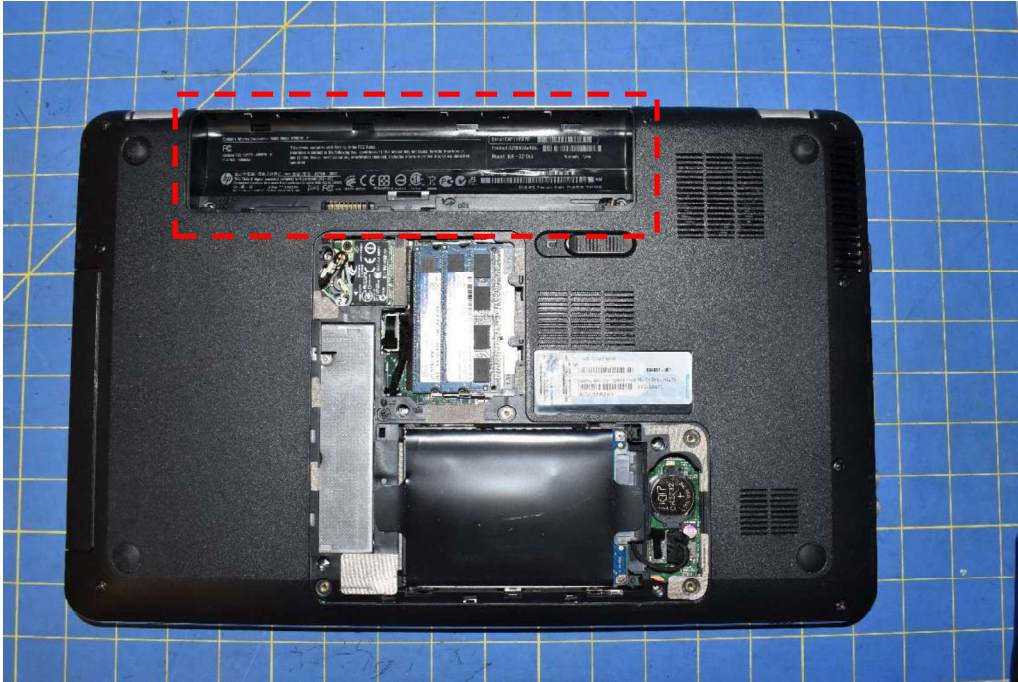
Figure 3. Bottom view of DV6 Computer

(Battery is removed, dotted line shows battery compartment)

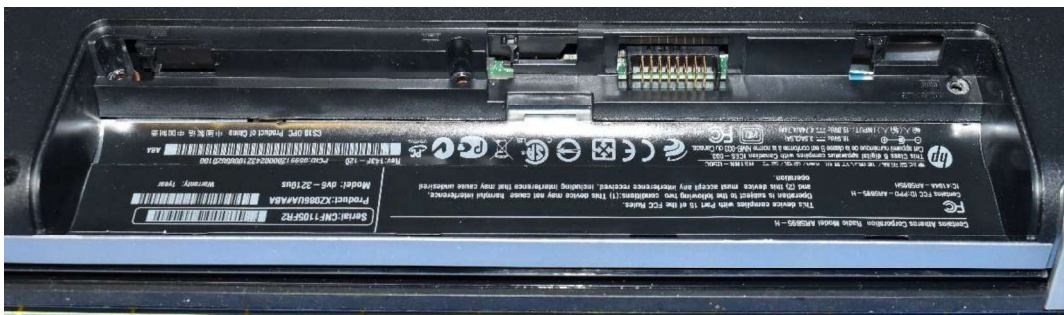
The battery compartment is shown in Figure 4. The computer operates with a 6-cell lithium-ion battery pack and can also be powered from an AC adapter. The power sources will be described in subsequent discussions.

Figure 4. Battery Compartment

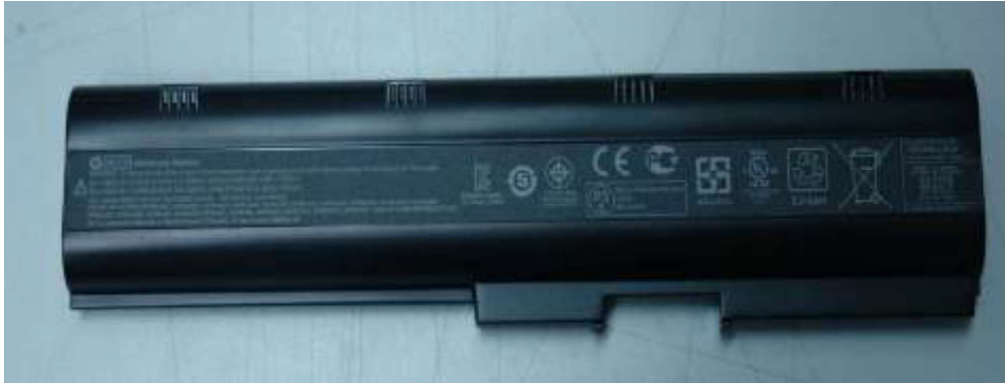
Figure 5 shows the battery pack when it is removed from the computer.

Figure 5. Battery pack removed from computer

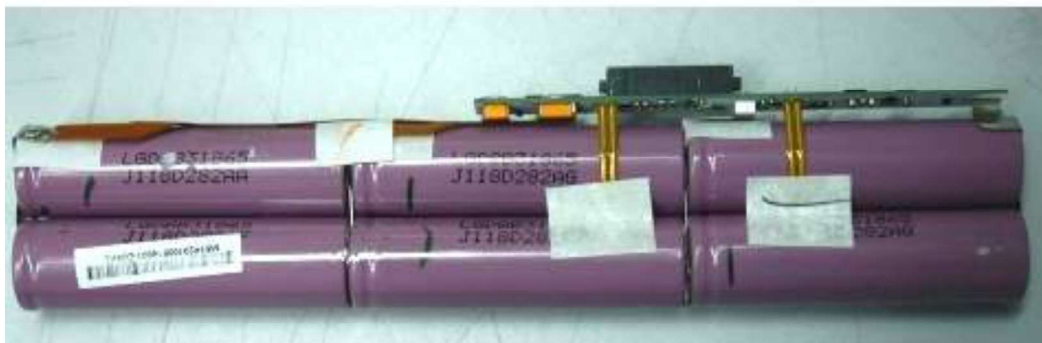
The battery pack consists of 6 cylindrical Lithium-ion batteries in metal containers. A photograph of a typical DV6 HPI battery pack is shown in Figure 6 with the outer plastic housing removed. The batteries (cells) are 18 mm in diameter (about 0.7 inches) and 65 mm long (about 2.5 inches). This battery type is usually referred to as an “18650”, because of its dimensions. The battery pack in the subject computer had 6 of these “18650” cells.

Figure 6. Interior of HPI battery pack showing cells and battery management circuit board.

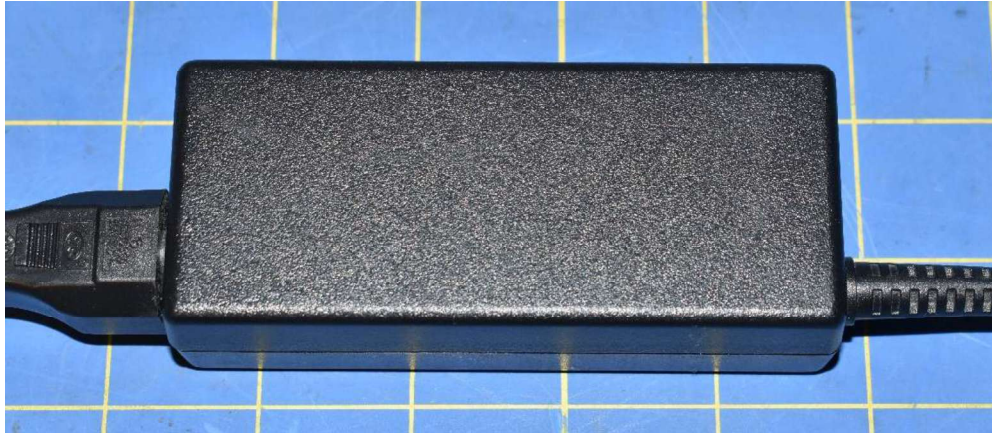
The top and bottom views of the AC Adapter are shown in Figures 11 and 12 respectively.

Figure 11 Top view of AC adapter

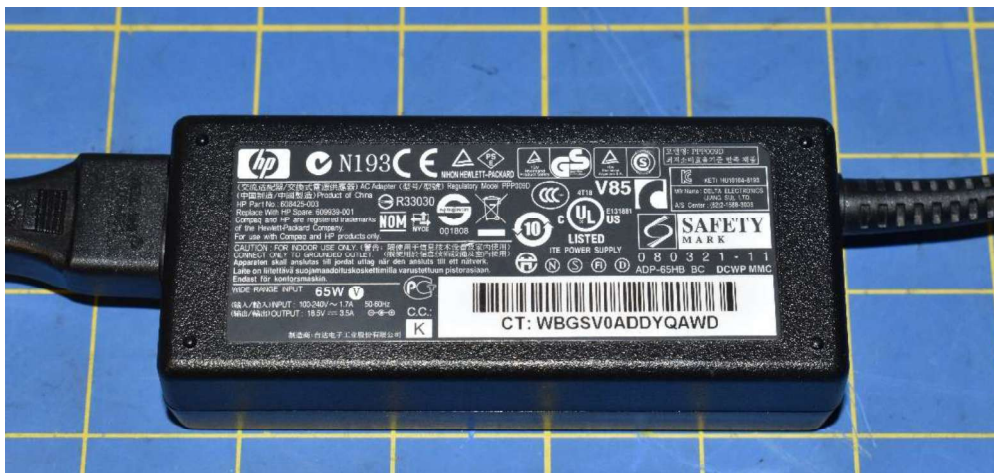
Figure 12. Bottom view of AC adapter

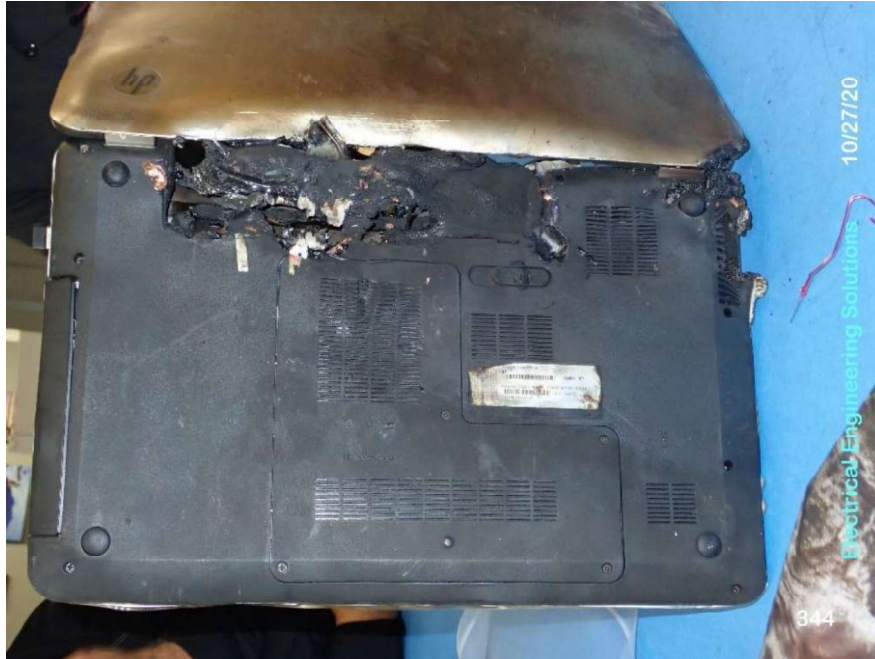
This computer was recovered from the desk area (where plaintiff has alleged the fire began). It is a model DV6-3210US HPI Pavilion. Photos of the top and bottom of the (alleged) subject computer are shown in Figures 13 and 14 respectively.

Figure 14. Bottom view of subject computer

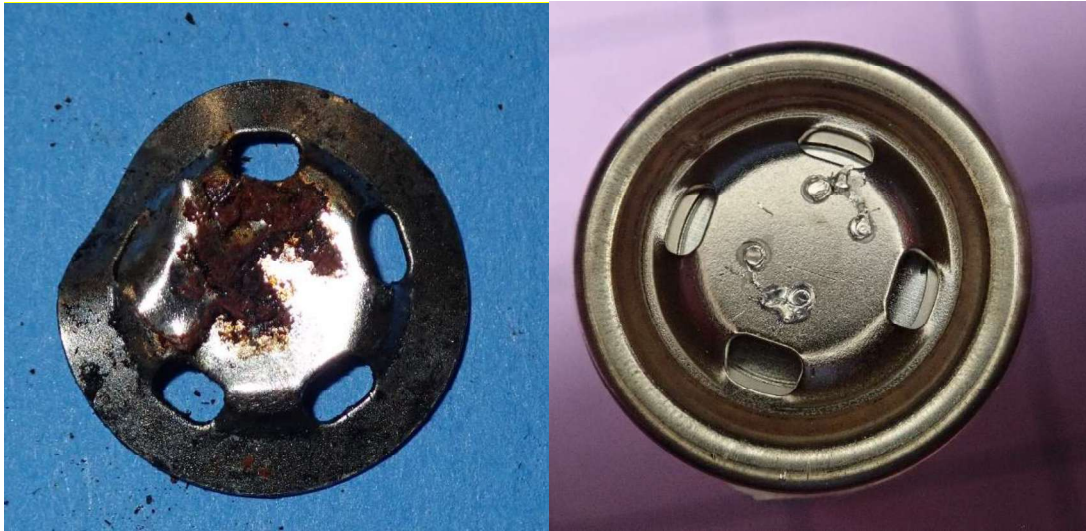
Each battery manufacturer has a specific hole pattern on the top cap of the cell. The cell caps for the subject battery (left) and the LG battery (right) that was shipped with the HPI notebook are shown in Figure 17 below. The subject cells have 5 vent holes whereas the original (LG) cells have 4 holes. HP00481 indicates the original pack was made by LG, with LG cells. The subject battery pack was not the one shipped by HPI.

Figure 17. Subject cell cap(left) and LG cell cap(right)
